REMCO OPERATORS COUNCIL NEWSLETTER

As the Rotor Turns - Trouble in Paradise

Producer resorts to rock-on-rock VSI use after many costly years of operating anvil style VSIs

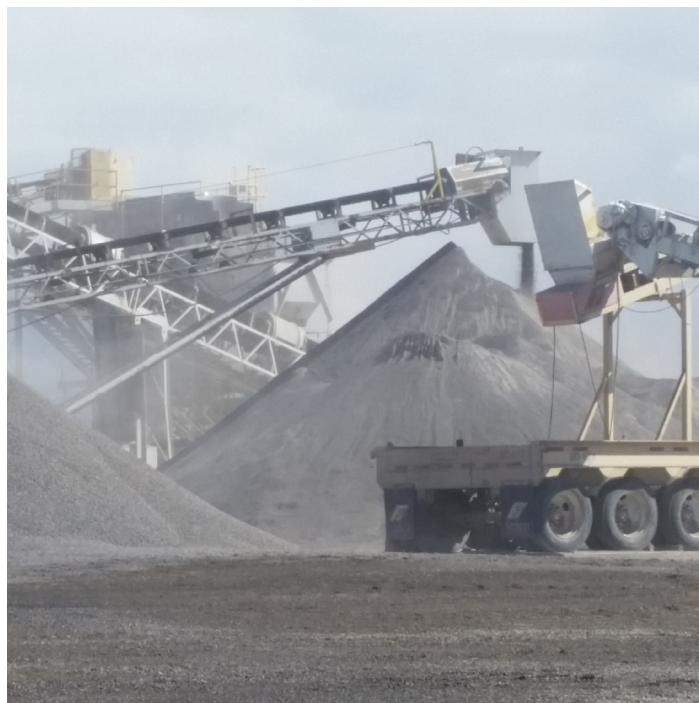
Figure 1: Cement company's final product pile minus #4 concrete sand.

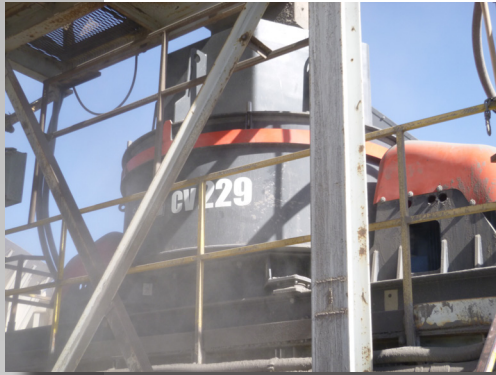
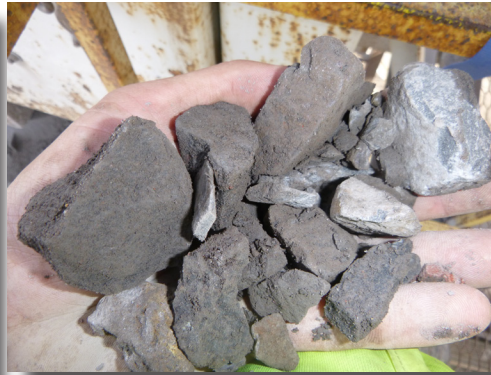
Figure 2: (left) Sandvik Model CV229 currently installed with a REMco 37-4-14 rotor (right) Customer feed size 2 1/2" being fed into the REMco 37-4-14 rotor.

In June 2015, Sandvik supplied a 700 HP (two 350 HP motors) Model # CV229 for the job complete with a variable frequency drive (VFD). During commissioning of the new VSI crusher is when things became difficult for the producer as problems began to surface and production suffered:

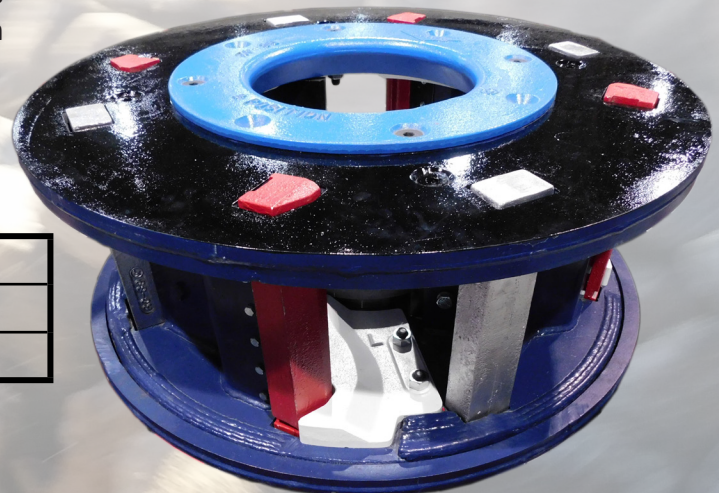
Rotor Size	37 - 4 - 14"
Max Feed Size	3" (77 mm)
RPM Range	1,500 - 2,000

Figure 3: Typical REMco 37-4-14 rotor.

- Disable Sandvik’s Bi-Flow system and force all material to go through a REMco rotor.
- Install a REMco 37” 4-port 14” rotor and 13” feed tube assembly.
- Allow REMco technicians’ access to the crusher to make necessary modifications along with their plant maintenance personnel so they could be trained on its operation.

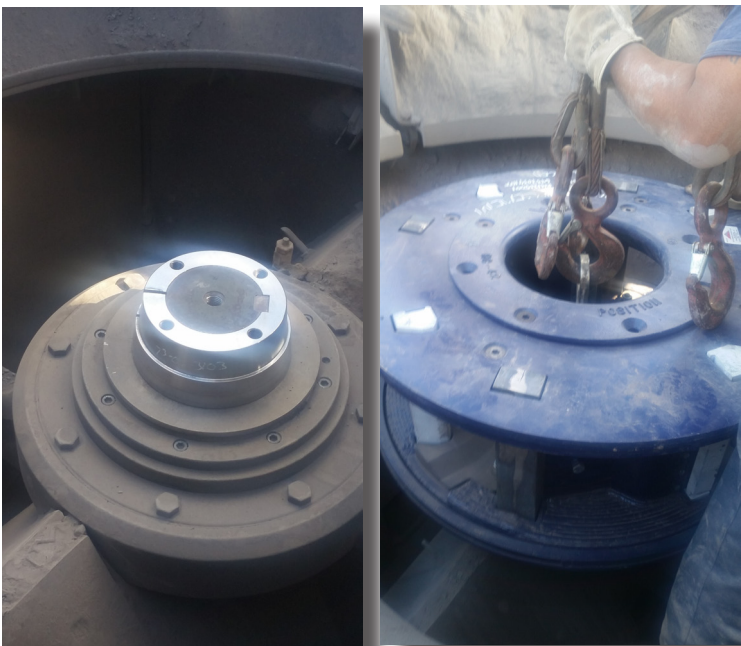
Figure 4: (left) REMco’s boss placed on the Sandvik bearing cartridge (right) 37-4-14 rotor being installed onto the bearing cartridge.

REMco offered these changes on a guaranteed performance basis and if we could not get the crusher to perform, our technicians would help restore the machine to its original state. The customer agreed to REMco’s proposal and the necessary components and technicians were on site in mid-January 2016 to make the change. After 12 hours of sweat, dust and comradery, the REMco / customer team had the crusher back in operation with impressive results.

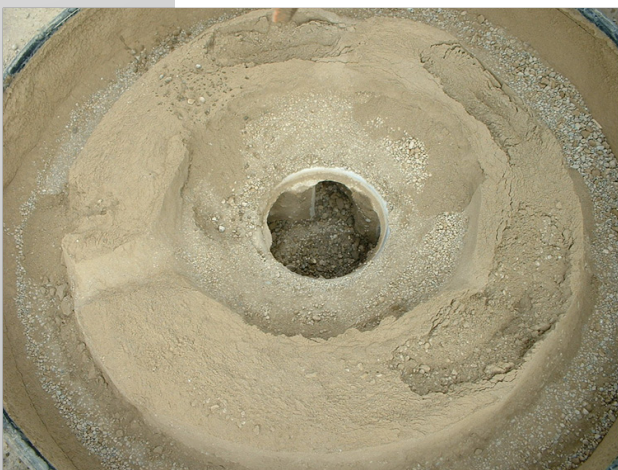
Wearing of the rotor boss skirt is a normal part of the crusher's operation and the reason for the skirt in the first place. However, this type of wear typically takes several thousand hours to occur. Premature wear on the rotor boss skirt is most often caused by excessive build-up in the crushing chamber, or drive tunnel or clogged discharge opening(s) that can cause material to build-up and rub directly on the rotor skirt significantly reducing its service life, see figure 1.

Figure 1: Extreme example of excessive build-up in the crushing chamber **causing the machine to stall.**

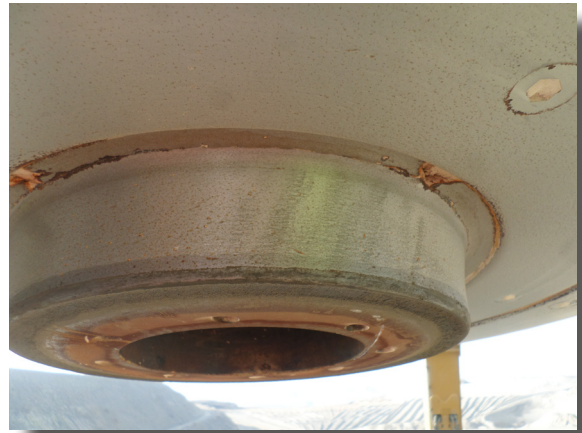
Poor operational practice such as extremely low feed rate will also cause premature wear to the rotor boss skirt due to excessive rebounding of crushed material back towards the center of the crusher, see figure 2.

Figure 2: Example of excessive wear on the rotor boss skirt (top) versus a new rotor boss skirt (bottom).

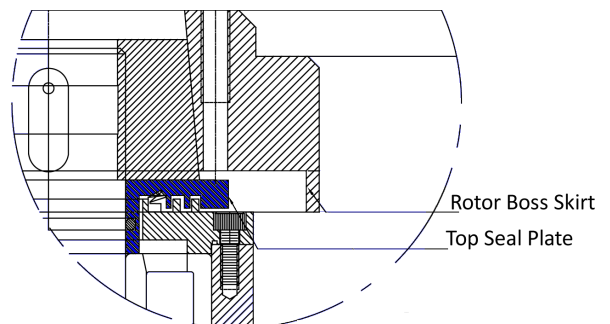
Figure 3: Detail view of the rotor boss skirt fitting on top of the REMco oil or grease bearing cartridge.

However, the easiest measure is this: with the rotor installed, inspect the area around the lower edge of the skirt; you should not be able to see the top seal plate, see figure 3 and figure 6.

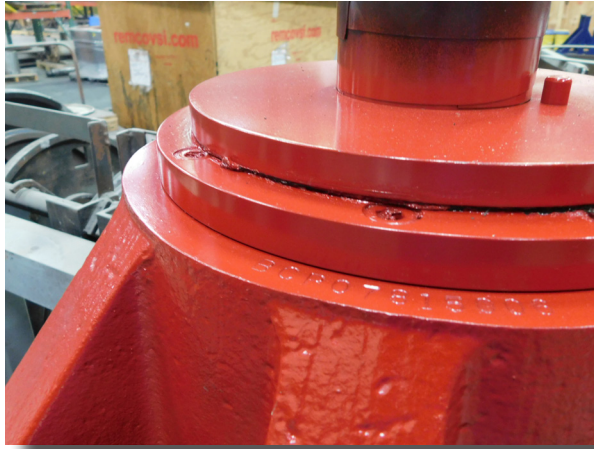
Figure 4: Example of new seal plate on bearing cartridge.

Maintenance personnel should inspect the rotor boss skirt and top seal plate each time the rotor is removed for service. This is a simple visual inspection to insure the skirt and seal plate look normal. Figures 4 and 5 are examples of new and worn skirts and seal plates. If anything looks suspicious check these areas further.

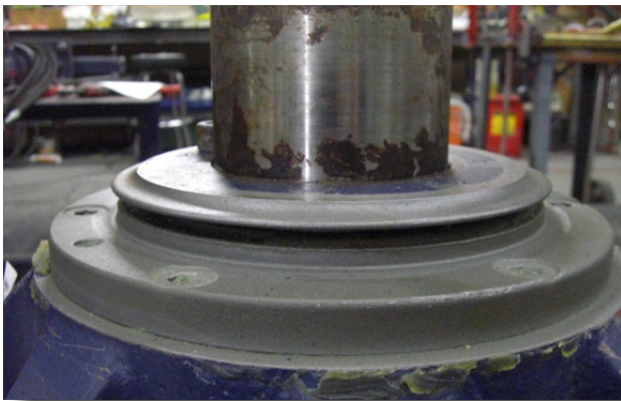
Figure 5: Example of excessive wear on the seal plate.

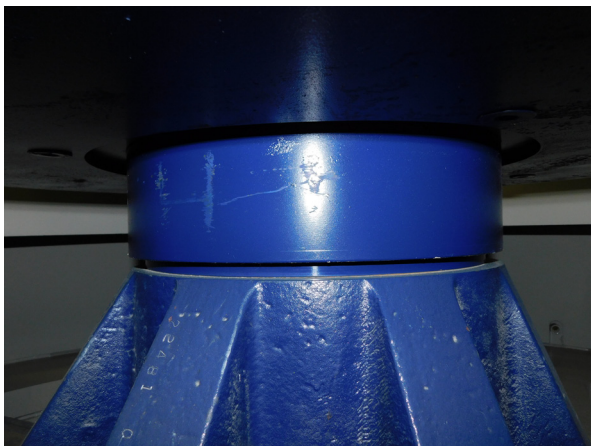
Figure 6: Example of how the rotor boss skirt should fit on top of the seal plate / bearing cartridge.
