# **REMCO OPERATORS COUNCIL NEWSLETTER**

# **Manufacturing Premier Sands**

# Advanced VSI technology boosts production of high-value, crushed-quartz golf course sand

# **REMco: Broken Tip versus Worn Tip**

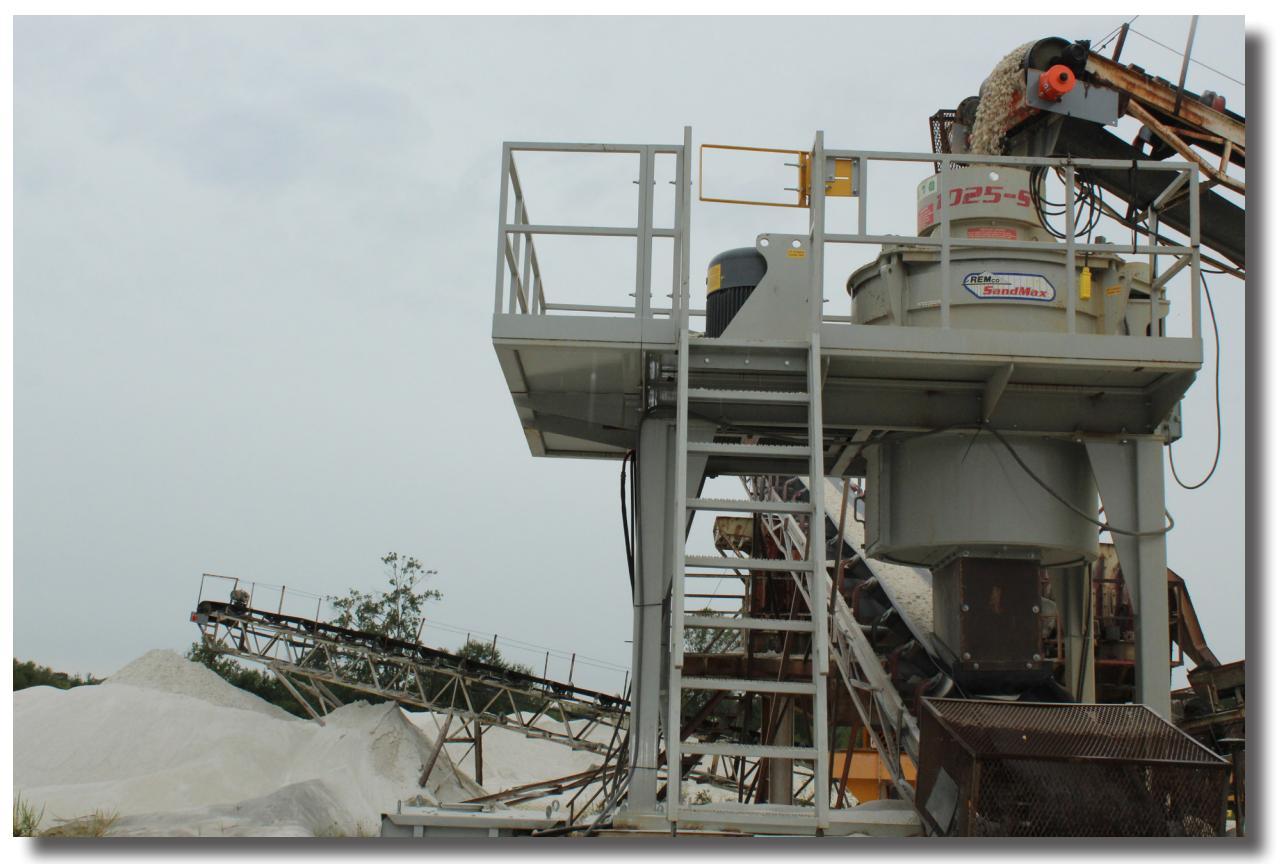
*Figure 1:* The Hayden Group has two Series 1025 VSI crushers in place in Arkansas, where it produces its Premier White sand that appears in bunkers on PGA tour golf courses.

Manufactured by REMco, a Series 1025 SandMax VSI Crusher (with 150 HP motor) was installed at the Hayden operation in 2016, with a second unit purchased shortly thereafter for a new plant. The REMco headquarters, its North American manufacturing operations, and its materials test crushing facilities are located in Livermore, California.

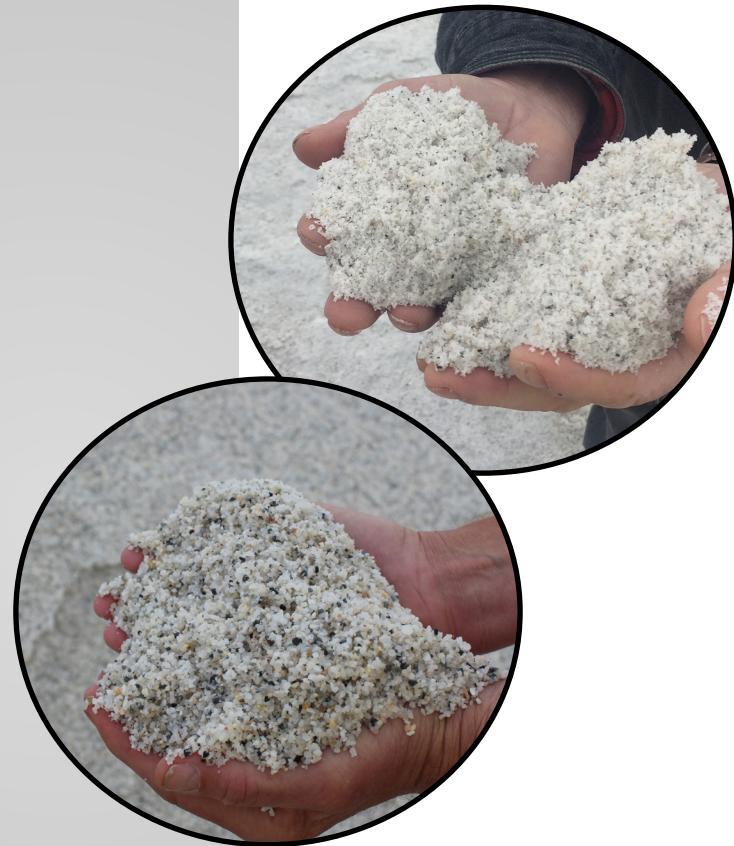
**Figure 2:** Golf course superintendents appreciate the aesthetics of the Hayden Group's bunker sand (top circle) and its drainage qualities. While the swimming pool industry benefits from the round pebbles, produced by the VSI (bottom circle).

At their two main plants, the new SandMax VSI crushers process all the Premier Sands<sup>™</sup>, as well as a white pebble product that the company sells to the swimming pool industry for high-quality, crystal-like pool finishes. Each of the crushing plants operate in a closed-circuit, allowing the operation to easily attain a consistent flow rate on every product that is processed.

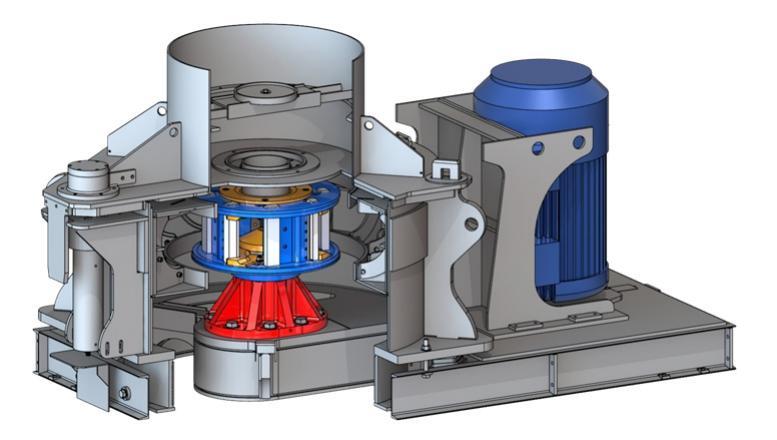
Figure 3: A cutaway of the REMco Series 1025 VSI Crusher.

Howell stresses that new rotor and chamber technology is key to advancements that boost productivity. "REMco has designed its VSI with a two-step, tapered rotor boss that's bolted-on and removeable. This essentially protects and preserves the longevity of the rotor itself," he says.

"The new VSI also features a tighter crushing chamber that's engineered to significantly increase production," adds Howell. He explains that the SandMax rock-on-rock crushing chambers are more closed and achieve a denser particle cloud within the crusher. This allows for a greater concentration of the crushing energy, which produces a finer discharge. "This high crushing velocity reduces material recycle and increases production capacities of a desired finished product with the best particleshape results," he says. Wear parts costs are also reduced on the new VSI. When operating previous competitive models, Hayden says that they were always replacing wear parts on a weekly basis. "Now, we get more than 200-hours on our wear plates. We do replace our tips weekly, but that only takes the crew about ten minutes to do," he says.

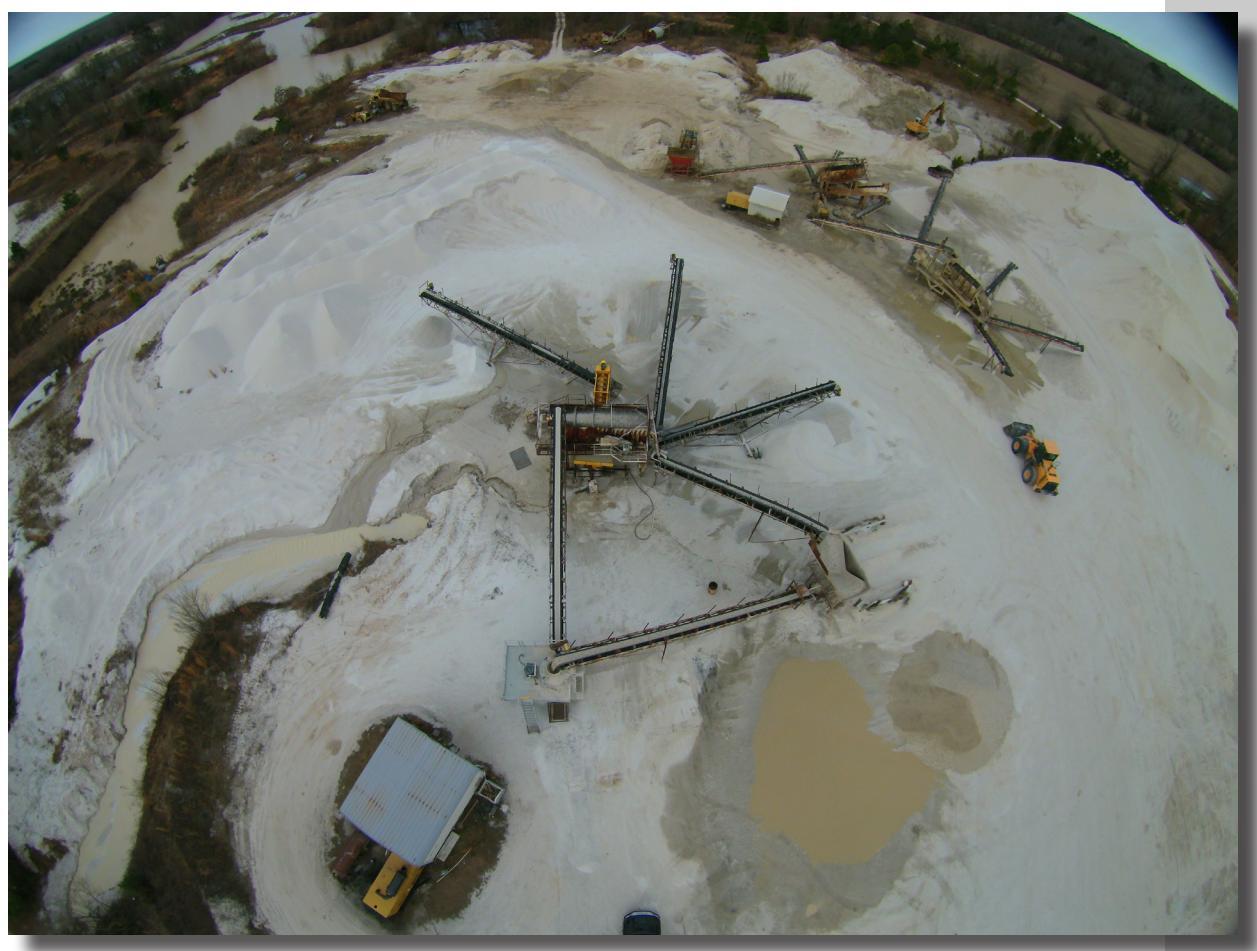
*Figure 4:* Keeping both player and greens supervisor perference in mind, The Hayden Group leverages its local quartz effectivly to fill bunkers at top courses around the nation. Above is an aerial view of the crushing plant.

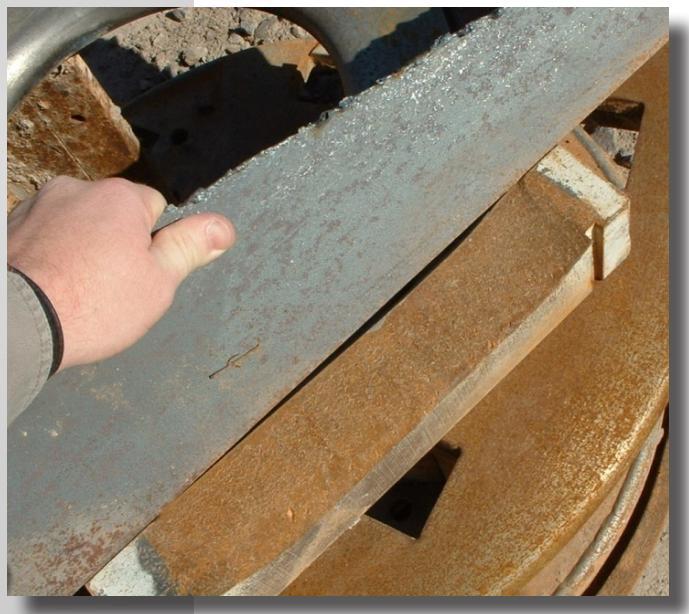
**Figure 1 (above):** Tungsten tips will normally wear in a smooth even arc shape. **Figure 2 (below):** The best way to determine tip wear is to actually measure it.

When the proper tungsten grade is applied, normal wear is concentrated in the center of the tip and can be measured by placing a straight edge from top to bottom of the tip (figure 1) and the wear can then be readily measured(figure 2). Normal feed rates will cause a smooth even wear pattern in the center of the tip. Low feed rates can cause the wear pattern to ride high or low on the tip depending on the feed size. Typically, small feeds will ride high, and larger feeds will ride low. Depending on your specific REMco rotor and REMco tungsten tip, the usable wear life of the carbide is between 3/4'' and 1 - 1/8''. Contact REMco for details on your tip part number.

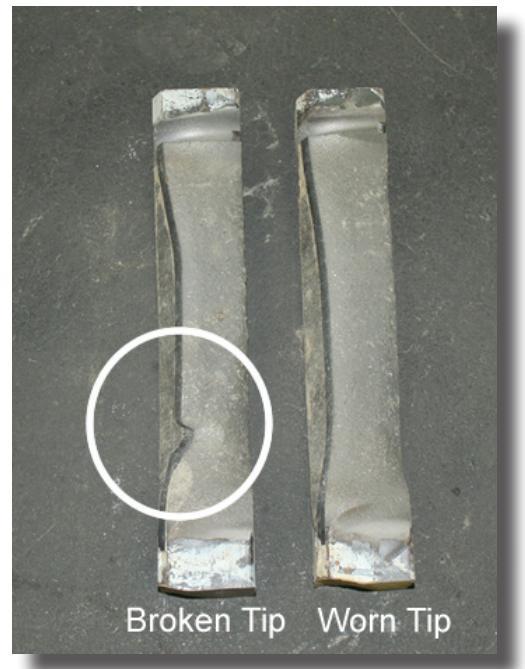
*Figure 3:* The picture above shows the difference between a broken tip (left) versus a worn tip (right)

It is easy to spot a broken tip when you know what to look for. A broken tip will have an abrupt gouge in the tungsten rather than the smooth wear indicated above (see Figure 3). Another tell tail sign is when one or two tips are damaged and the remaining tips indicate normal wear.

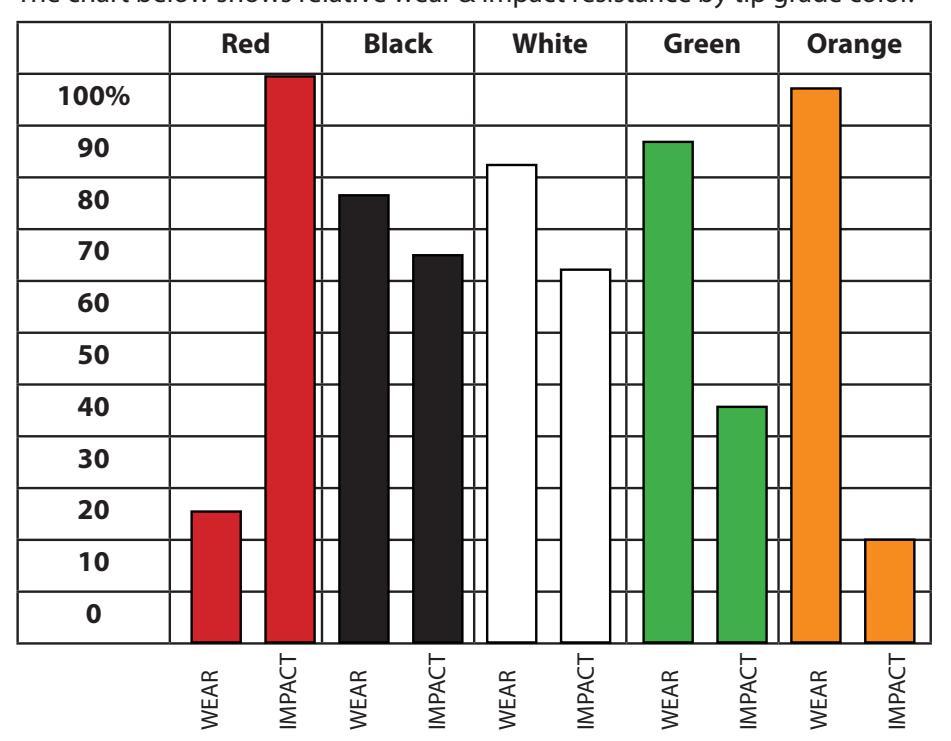
# **Tungsten Grade Selection Guide for REMco Tungsten Tips**

The chart below shows relative wear & impact resistance by tip grade color.

Feed size: Each tungsten grade has a recommended feed size for which it is best suited. Feeding material to the rotor that is in excess of the tip color guidelines (see chart) can cause breakage of the tungsten carbide and premature failure of the tip. The tungsten tip color chart has been developed to provide the operator a guide to balance wear resistances and impact resistances. Small feeds can use harder carbide to increase their wear resistances, however, the impact resistance is reduced. Likewise, larger feeds require greater impact resistances and wear resistances is reduced. Finding the best balance begins with the tip color chart, but is ultimately determined by characteristics of the customer's specific material. Contact REMco for guidance with your specific application details.
